Rainbow School Nerok Zanskar Multi-Purpose Auditorium Hall Progress Report 2025

Construction Report No2

- ❖ Report on Multi-purpose Auditorium Hall from 22nd June to 2nd of September 2025

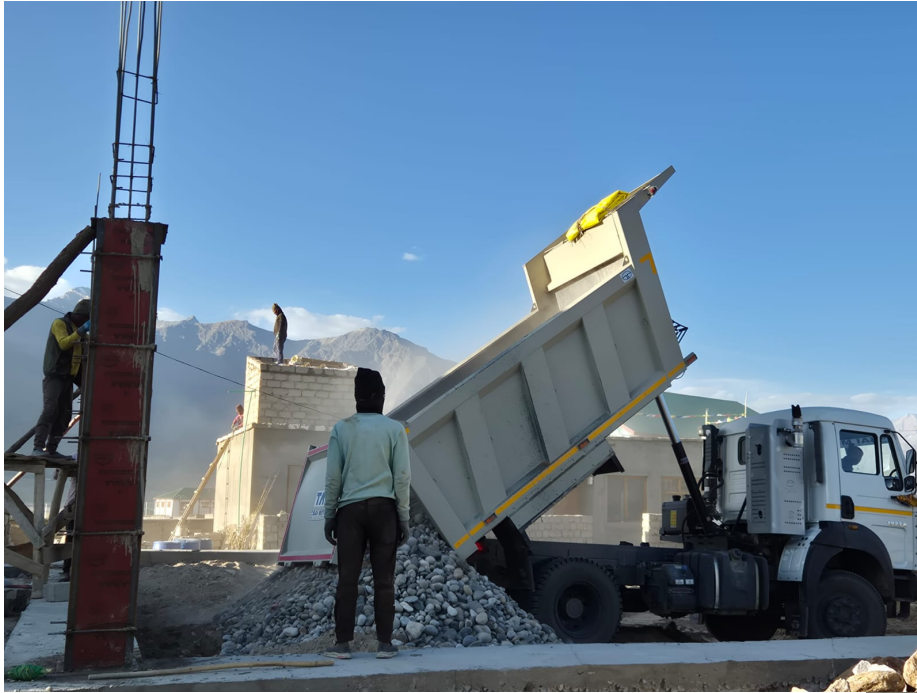
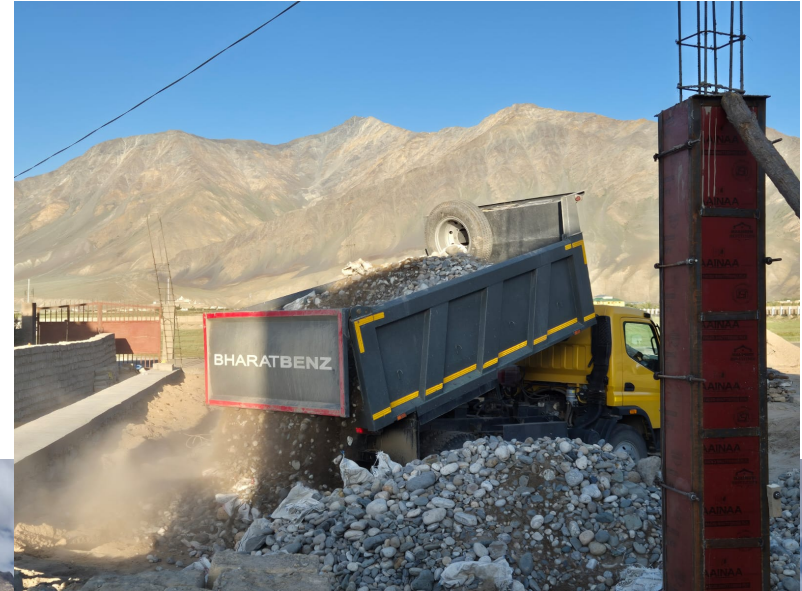
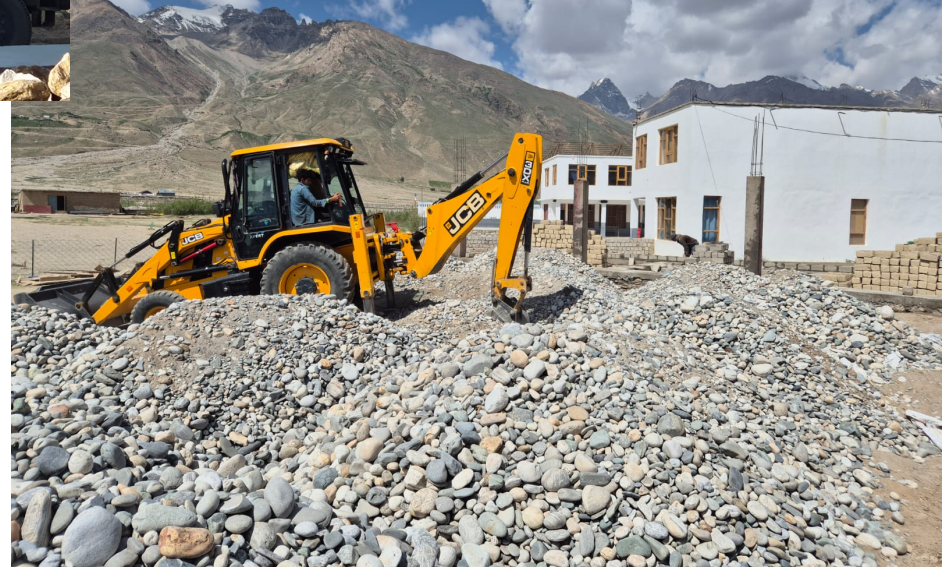
Filling of Foundation

After raising the foundation up to 3 feet above ground level, we have started filling the foundation with gravel of random sizes. The filling is carried out with proper levelling using shovels, and labourers have ensured an even surface.

On top of the gravel filling, insulation will be provided using straw-clay bricks, followed by a 4-inch layer of PPC (Portland Pozzolana Cement). Finally, the structure will be completed with finished wooden flooring.

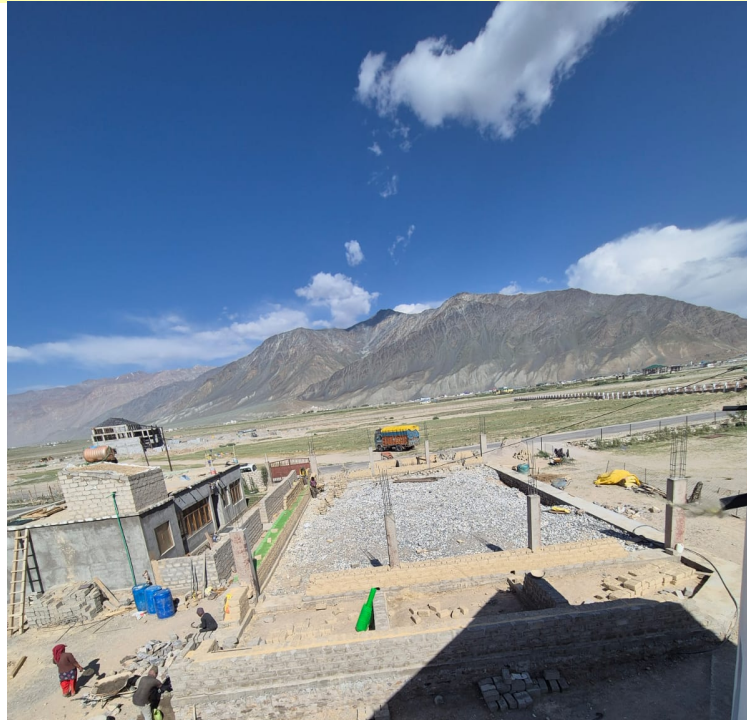
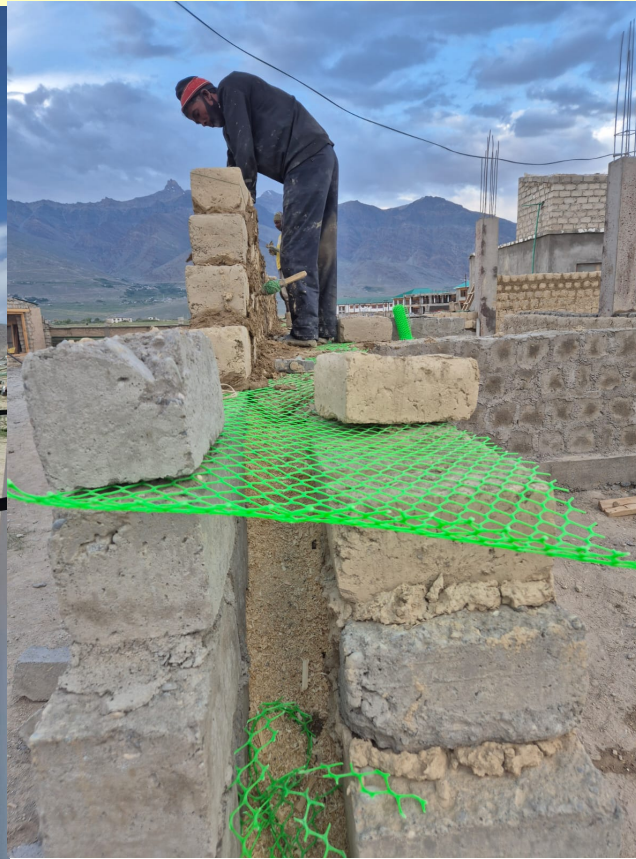
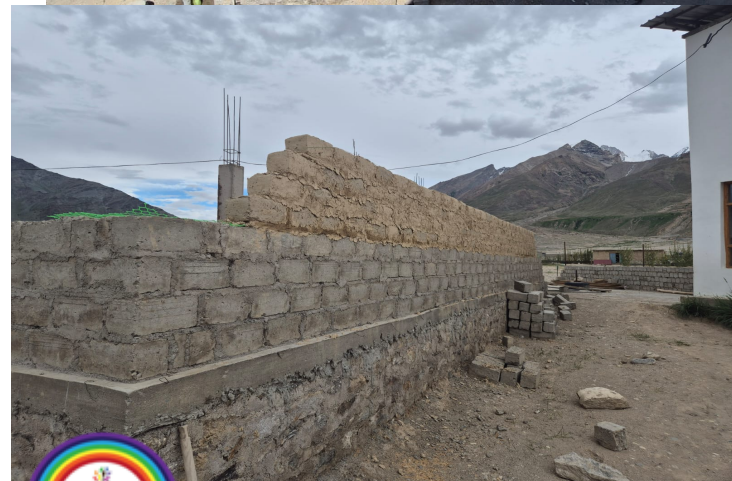
Wall Construction

The walls are being constructed using a cavity-wall system. The cavity is filled with sawdust, which serves as an insulation material. The sawdust is compacted (rammed) in layers to achieve the required density and stability, resulting in a total wall thickness of 24 inches. To enhance structural integrity, geo-mesh reinforcement is installed at every 4 feet of height, effectively tying the two wall leaves together and ensuring overall strength and durability of the wall system.

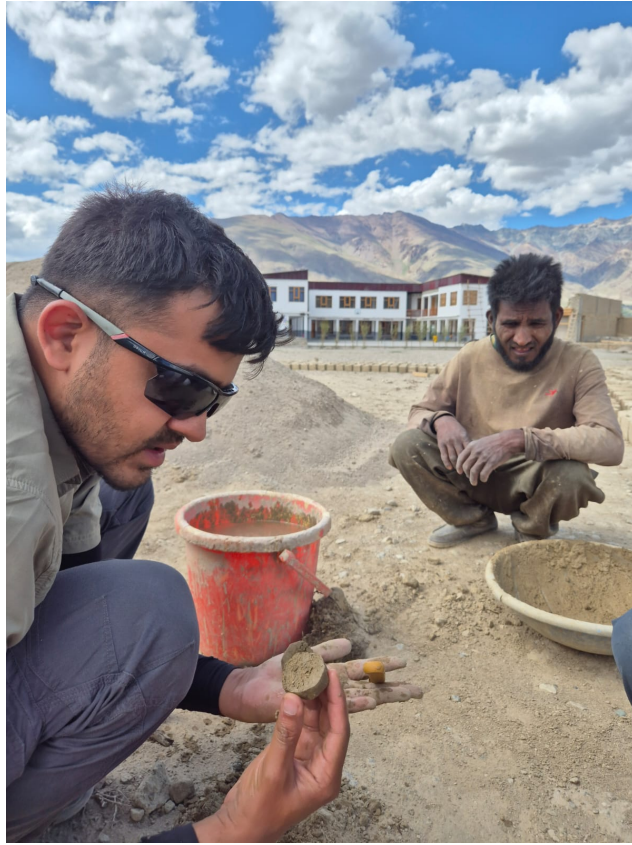
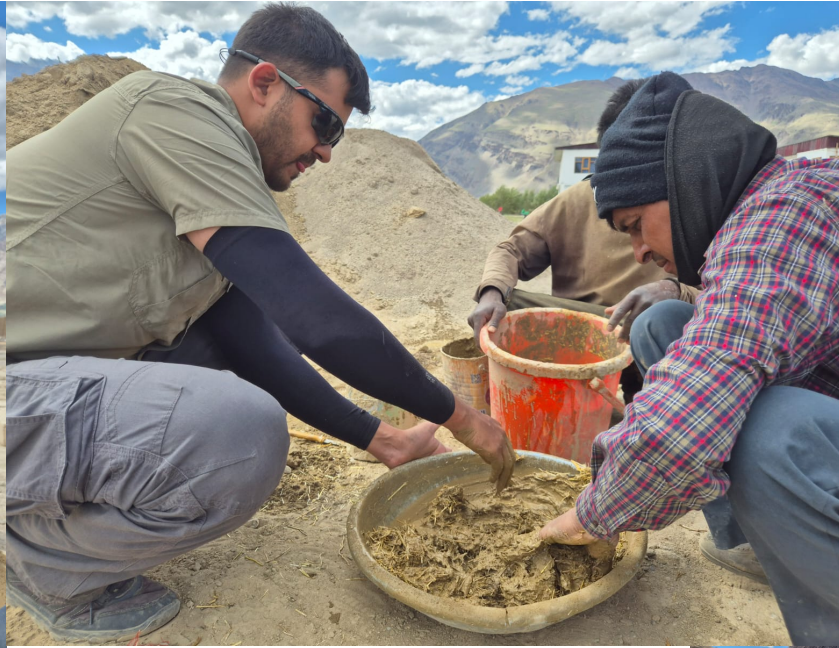
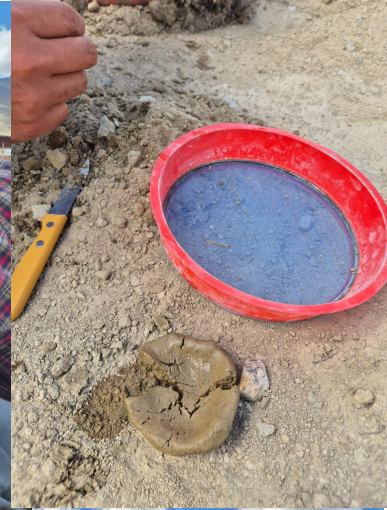
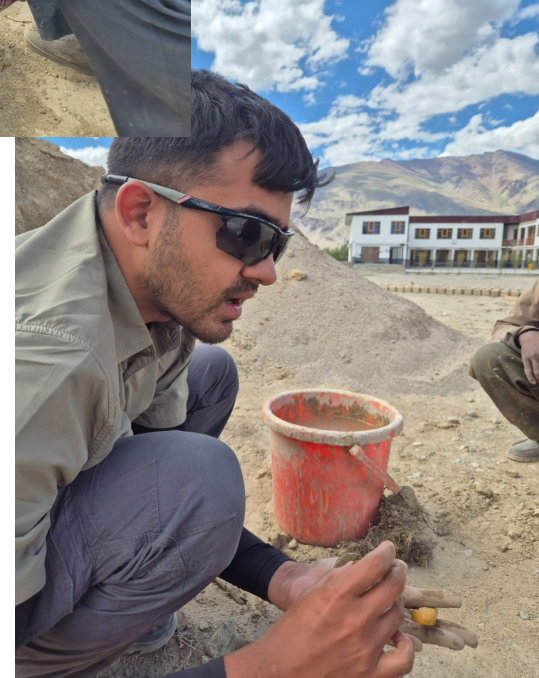
Soil Testing

Soil testing was carried out under the supervision of **HAIL Architect, Mr. Shubham Ray**, in coordination with **Contractor, Mr. Deb Bahadur Sunar**. The primary objective of the testing was to determine the relative proportions of clay, silt, and sand in the locally available soil, in order to identify its suitability for the production of high-quality mud bricks as well as for compacted straw–clay bricks.

Different testing methodologies were applied to evaluate soil composition and performance, ensuring optimal mix ratios for strength, durability, and workability in brick preparation. The results will guide material selection and standardization for subsequent construction activities.

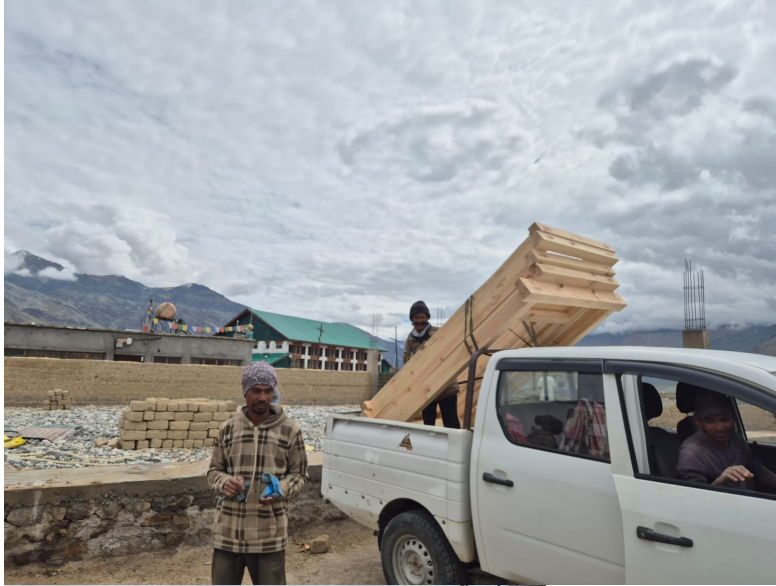
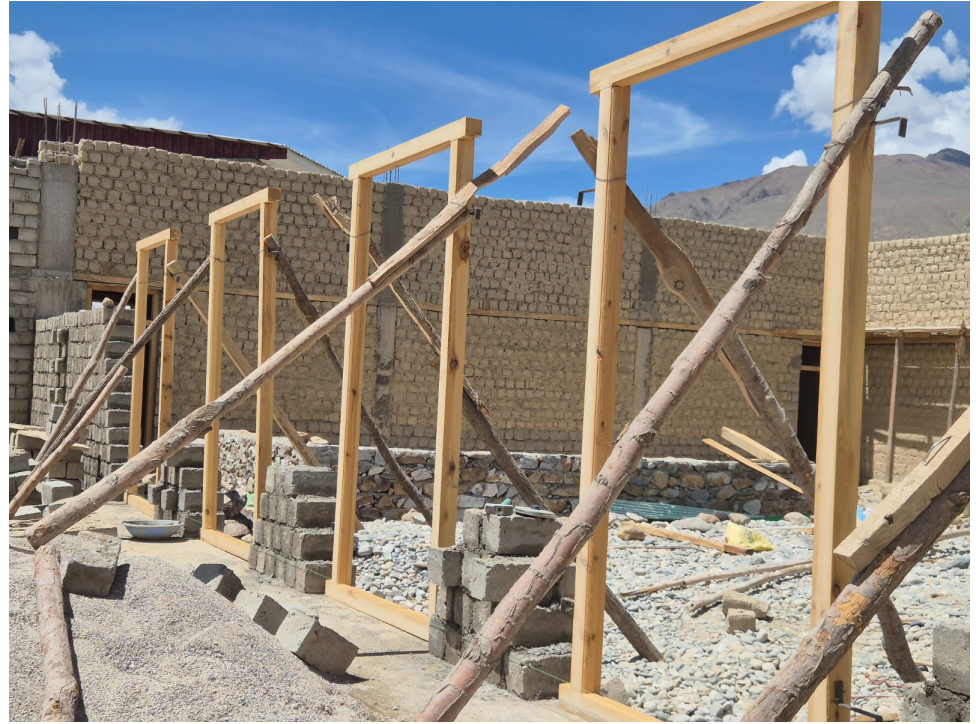
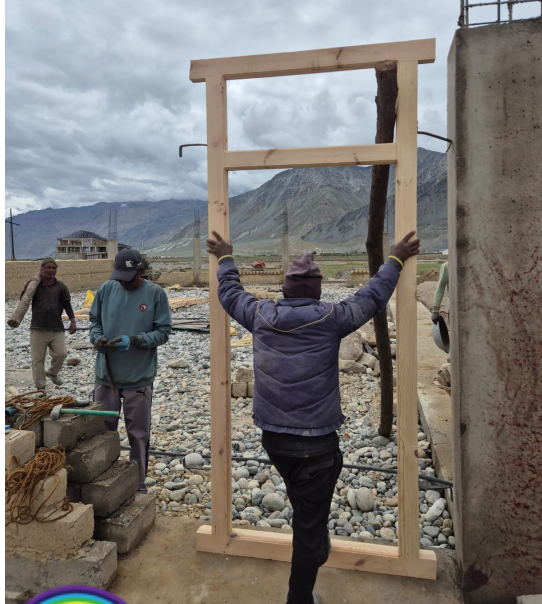
Installation of Interior Windows and Door Frames

The installation of interior window and door frames has been initiated as per the approved architectural layout. Frames are aligned vertically and horizontally using water levels and plumb lines to ensure accuracy in placement. Proper anchoring methods are employed to secure the frames firmly within the wall cavities, thereby maintaining structural stability and alignment.

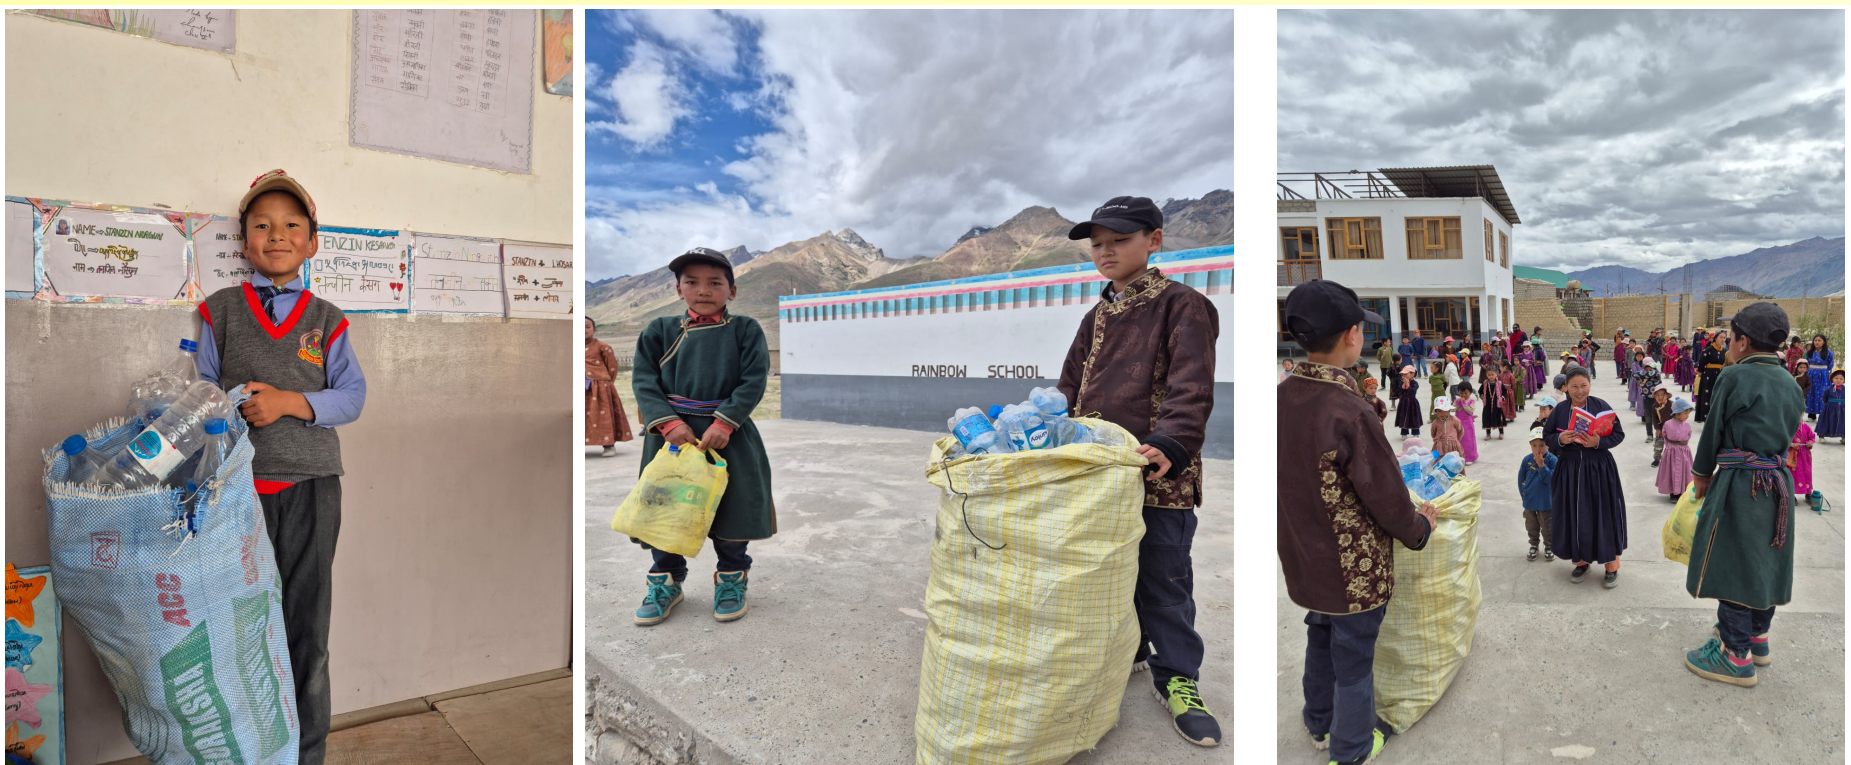
Student Contribution – Plastic Bottle Collection for Thermal Wall

Students of our institution continue to contribute actively towards sustainable construction practices by collecting empty plastic bottles. This initiative serves a dual purpose: firstly, it supports environmental cleanliness by reducing plastic waste from the community; secondly, the collected bottles are repurposed in the construction process for the fabrication of thermal bricks. These thermal walls, incorporating plastic bottles as insulating elements, enhance energy efficiency while simultaneously addressing waste management concerns, thereby aligning with the project's vision of eco-friendly and sustainable building practices

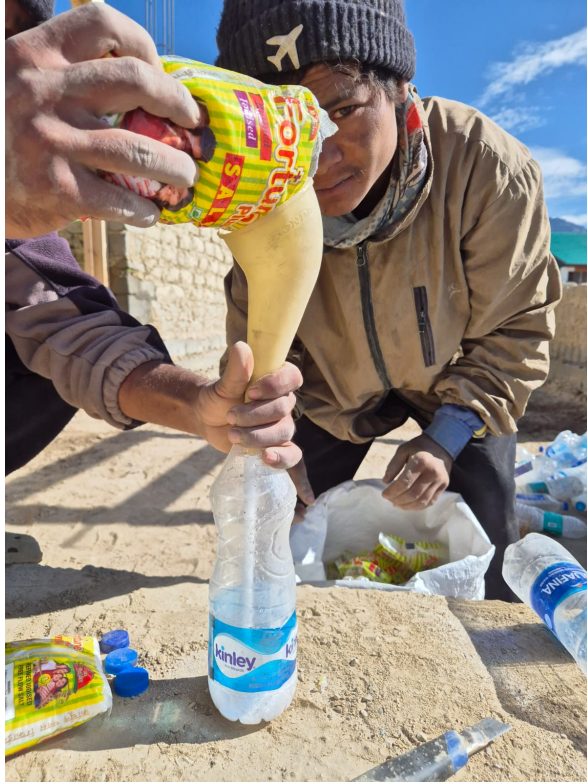
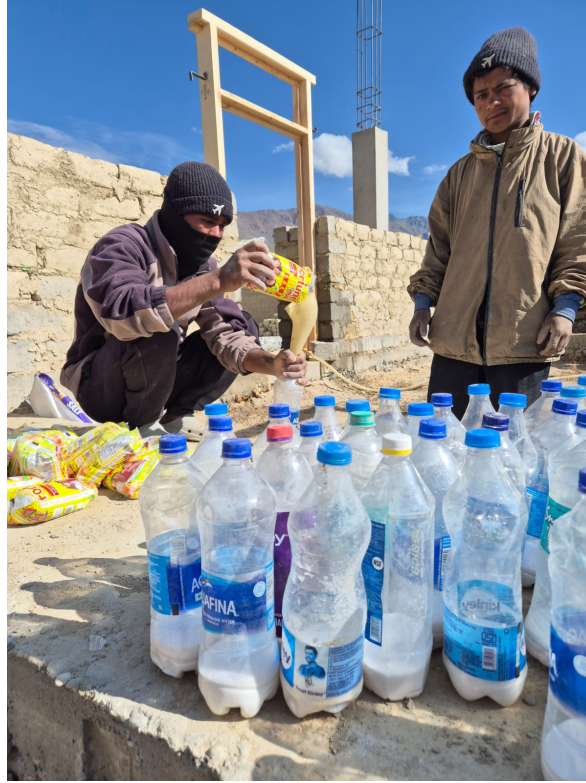
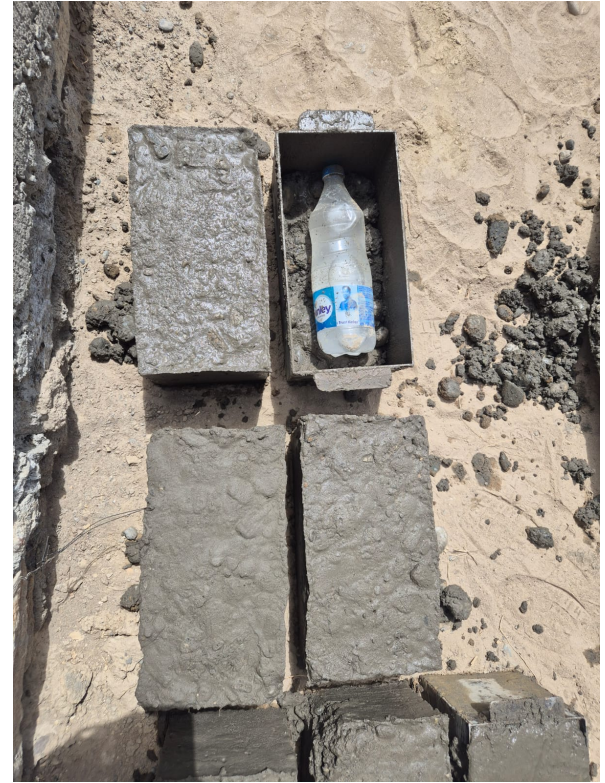
Fabrication and Placement of Thermal Bricks

Workers carefully prepare thermal bricks by filling empty plastic bottles with salt and subsequently adding water to enhance their thermal mass. These filled bottles are then cast into concrete blocks, forming composite thermal bricks.

The thermal bricks are strategically installed along the **south-east facing walls** of the building to maximize heat retention and improve overall thermal performance. This method not only contributes to passive heating but also incorporates waste materials into functional construction elements, supporting both sustainability and energy efficiency objectives of the project.

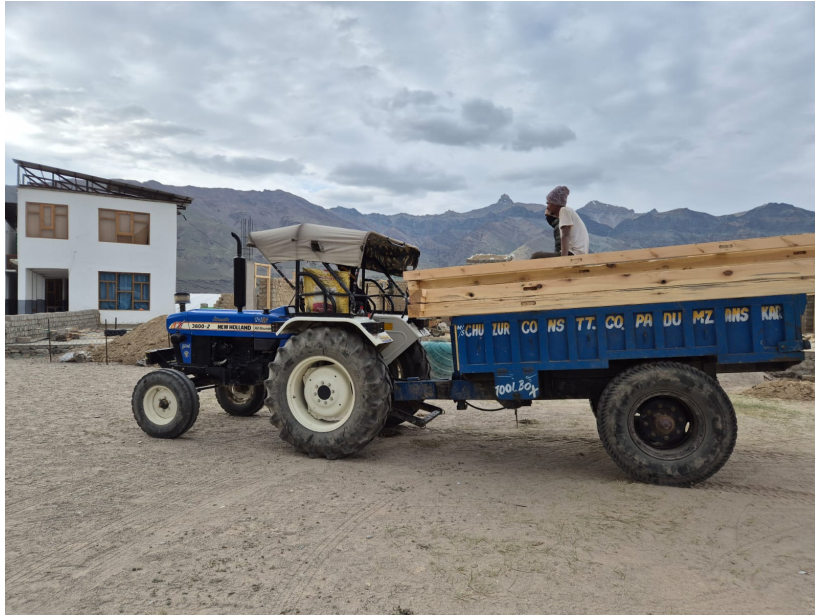
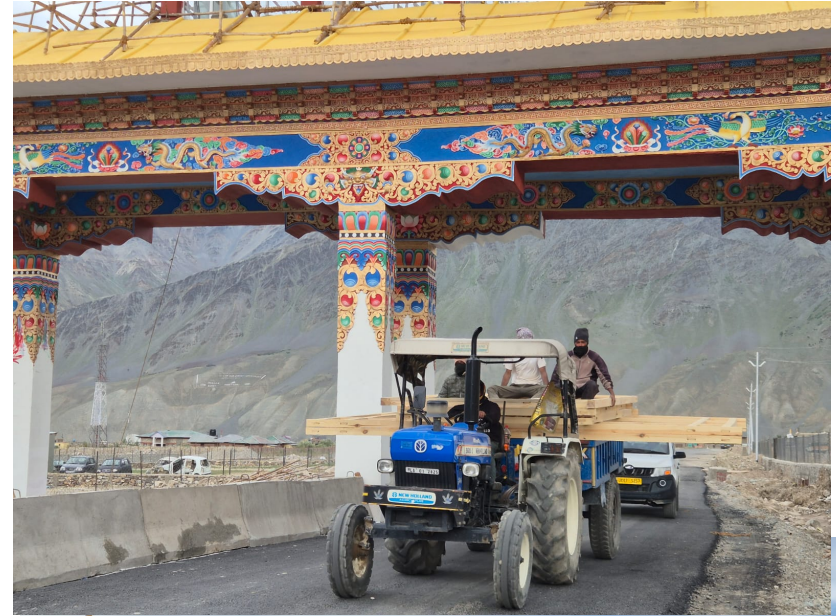
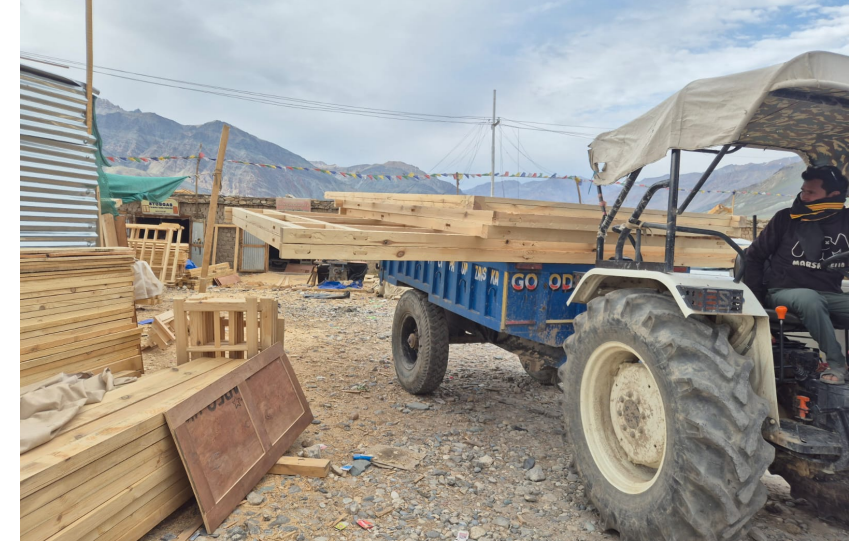
Transportation of Exterior Window Frames

Exterior window frames, fabricated at the local workshop as per approved design specifications, have been transported to the construction site. Care was taken during handling and transportation to prevent damage, bending, or warping of the frames. The frames will undergo inspection upon arrival to verify dimensional accuracy, surface finish, and structural stability prior to installation. This step ensures quality compliance and readiness for integration into the building envelope.

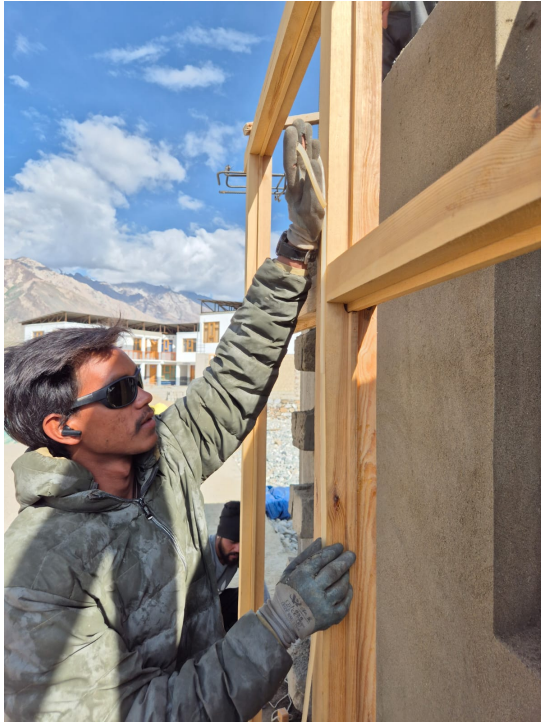
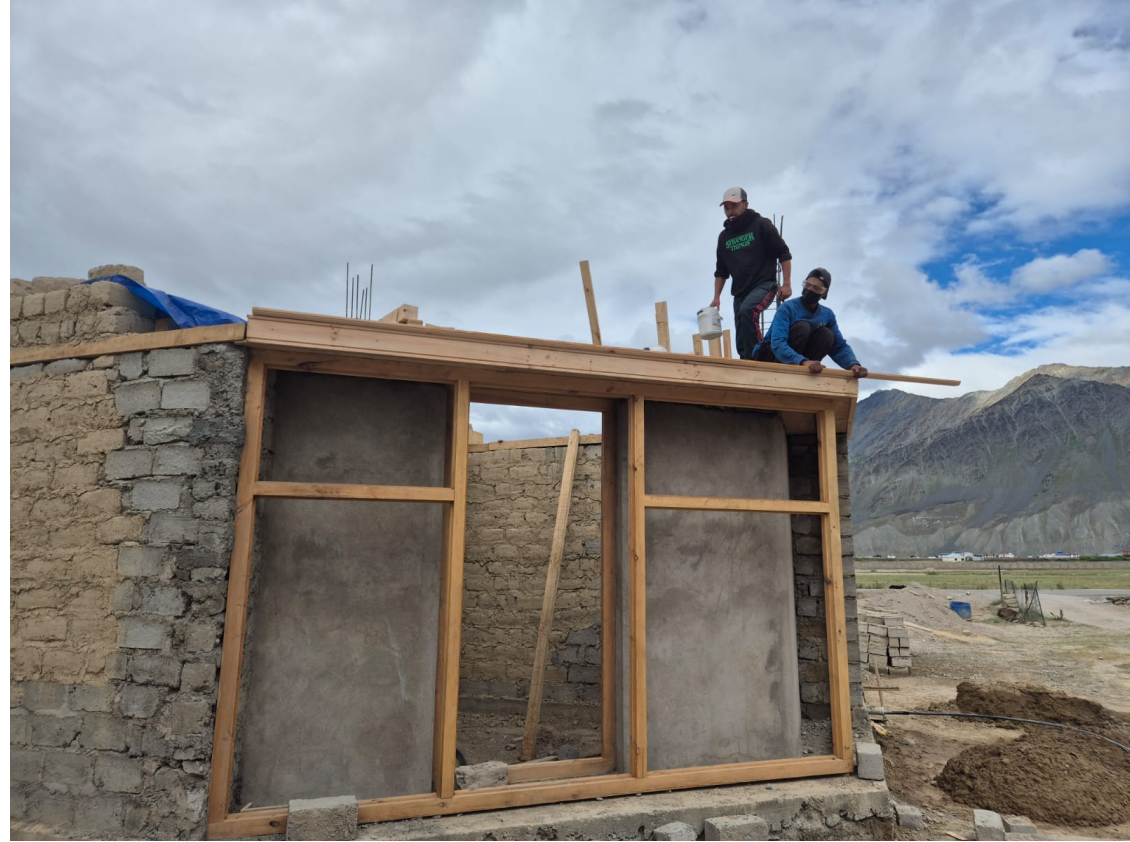
Installation of Exterior Windows

The installation of exterior windows has commenced for the side rooms. Skilled technicians are carrying out the process with precision, ensuring proper alignment and positioning. A water level pipe is employed to verify both horizontal and vertical alignment, thereby guaranteeing accuracy and uniformity across all window Frames.

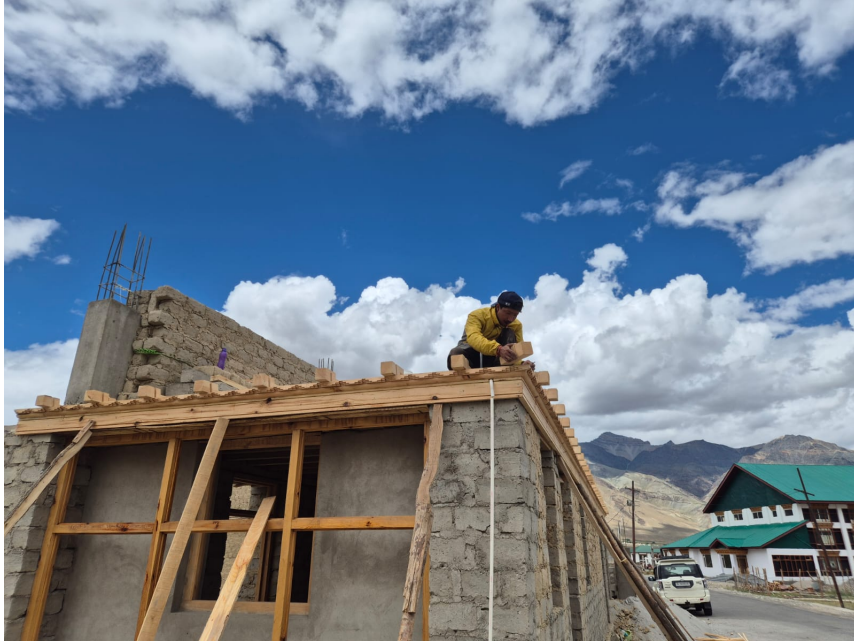
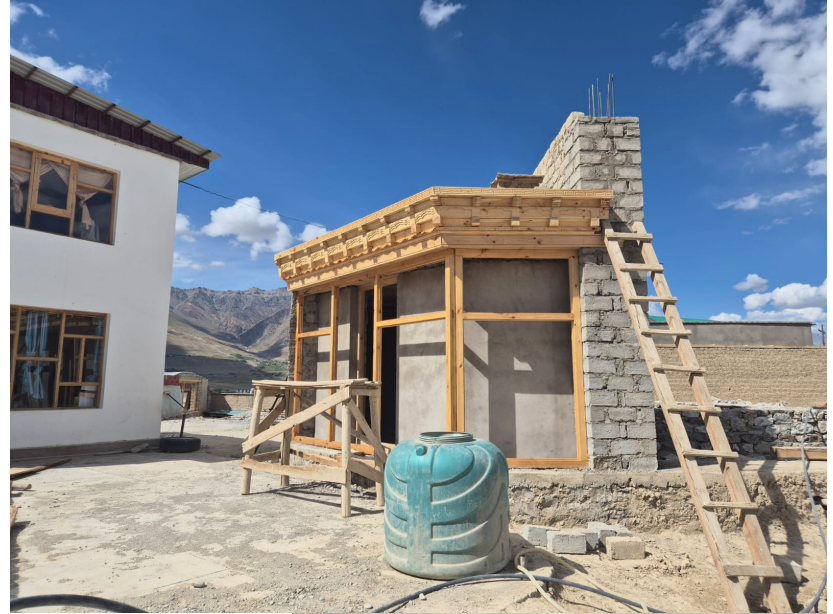
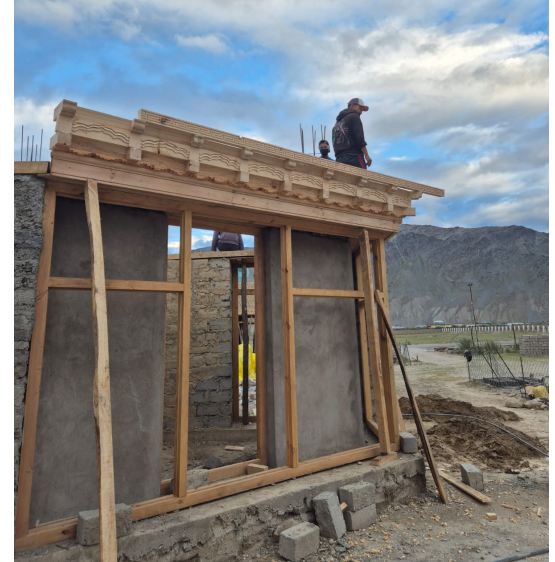
Installation of Traditional Shinsak

To preserve the cultural aesthetics of the building, local carpenters have installed **Shinsak** (traditional carved wooden elements) over the exterior windows. These handcrafted wooden details not only enhance the architectural character of the structure but also reflect the traditional craftsmanship of the region.

The Shinsak elements have been securely fixed above the window frames, ensuring both durability and alignment with the overall façade design. This integration of traditional artistry with modern construction provides the building with a distinctive cultural identity while maintaining functional performance.

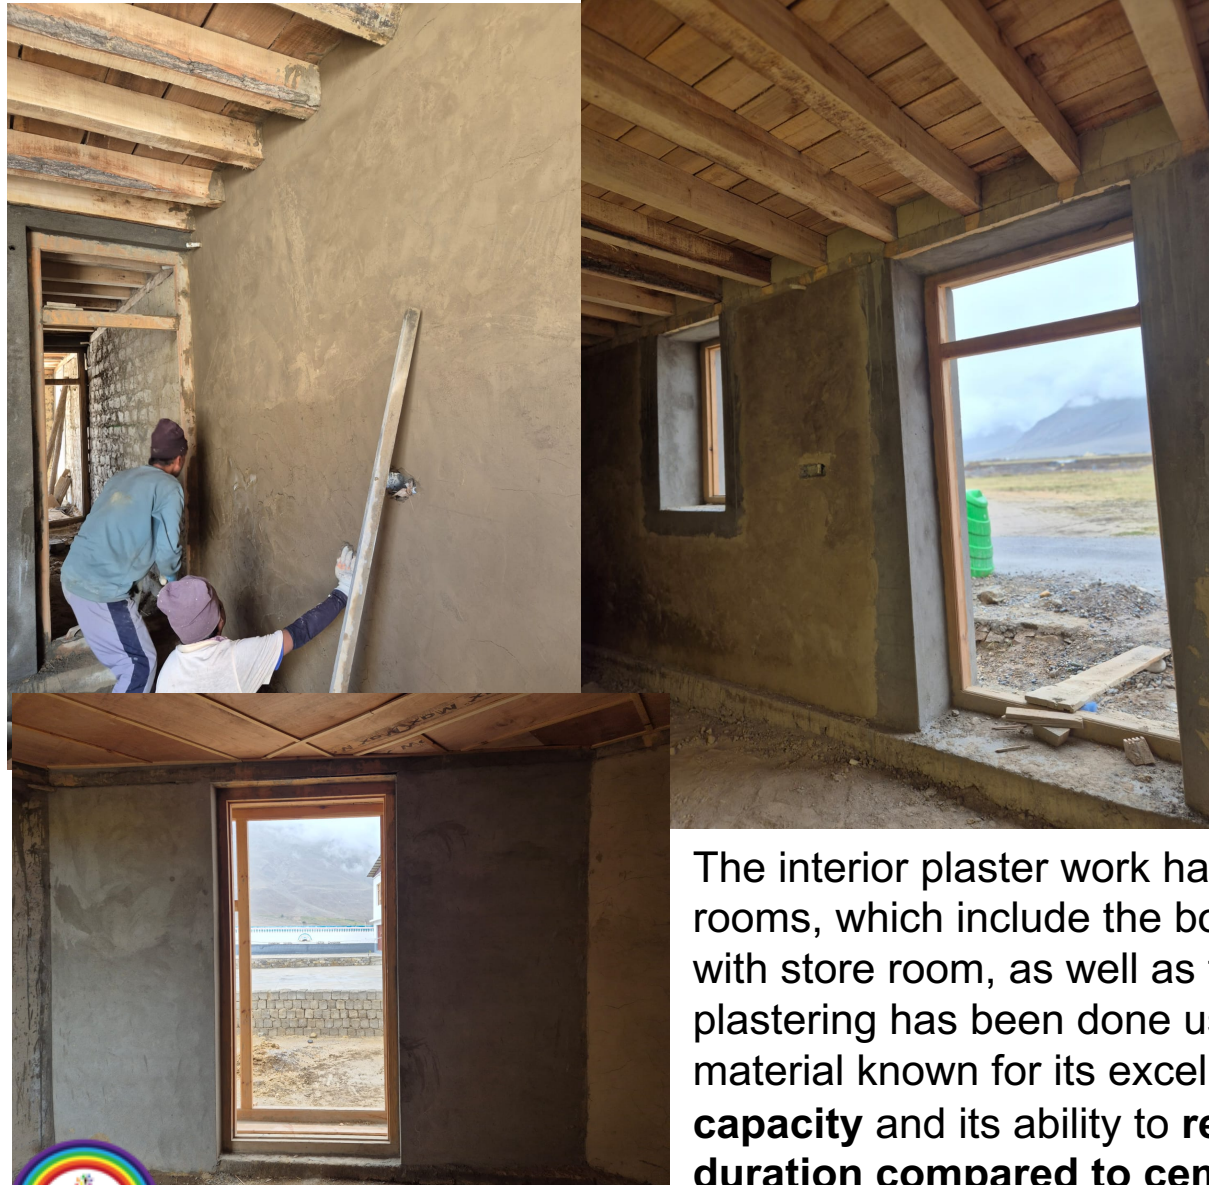
Interior Plaster Work Update

The interior plaster work has been completed in the side rooms, which include the boys' and girls' changing rooms with store room, as well as the cafeteria and kitchen. The plastering has been done using **mud plaster**, a traditional material known for its excellent **moisture absorption capacity** and its ability to **retain temperature for a longer duration compared to cement**.

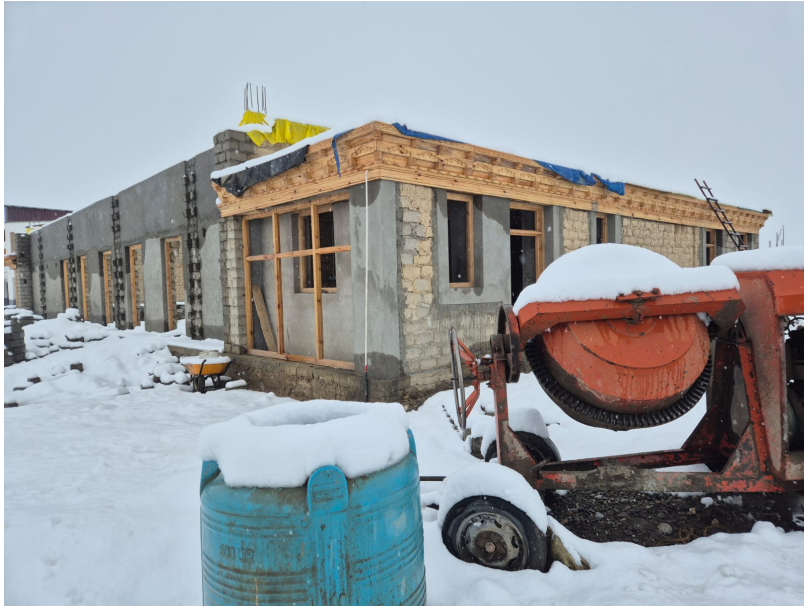
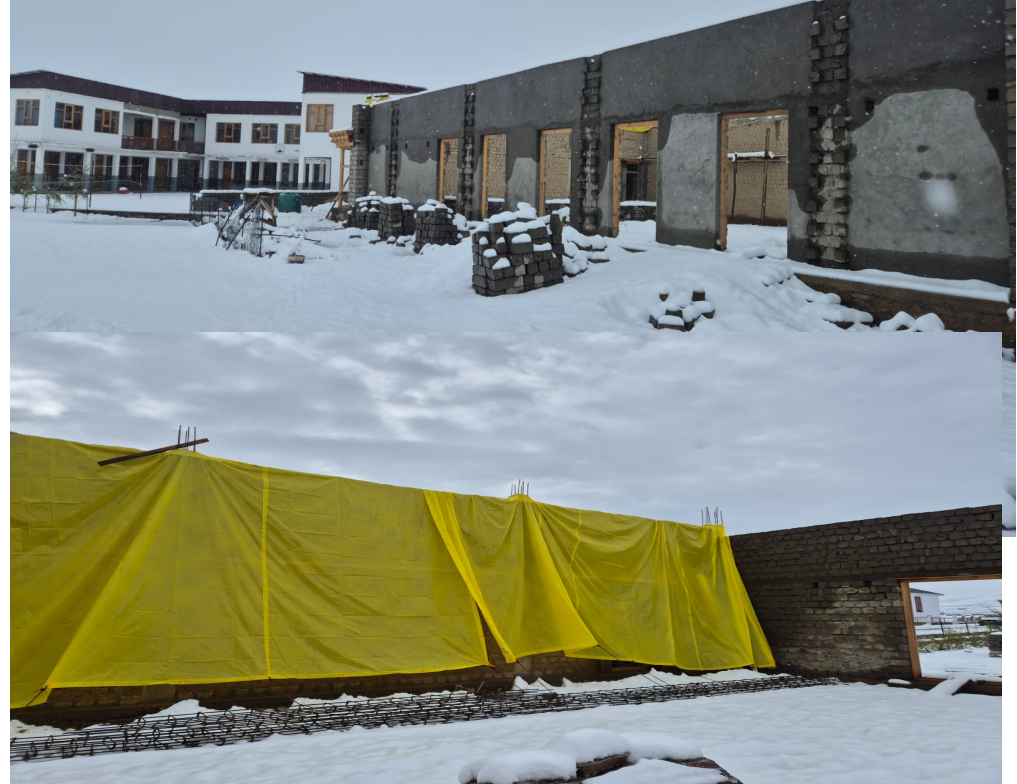
Impact of Unseasonal Weather on Work Progress

Construction activities were adversely affected due to unseasonal weather conditions beginning on **25th August**, when Ladakh experienced **four consecutive days of heavy rainfall** followed by **two days of unexpected snowfall**. Against the normal average rainfall of **15 mm in August**, the region recorded an unprecedented **47 mm**, leading to widespread disruption. The excessive rainfall and snowfall resulted in flash floods, causing damage to roads and bridges across Ladakh. The situation was further compounded as **Manali, Himachal Pradesh** emerged as one of the worst-affected areas, with road connectivity from **Delhi to Manali** remaining cut off to date. This has directly impacted the timely transportation of construction materials and supplies to the site, leading to unavoidable delays in the progress of work

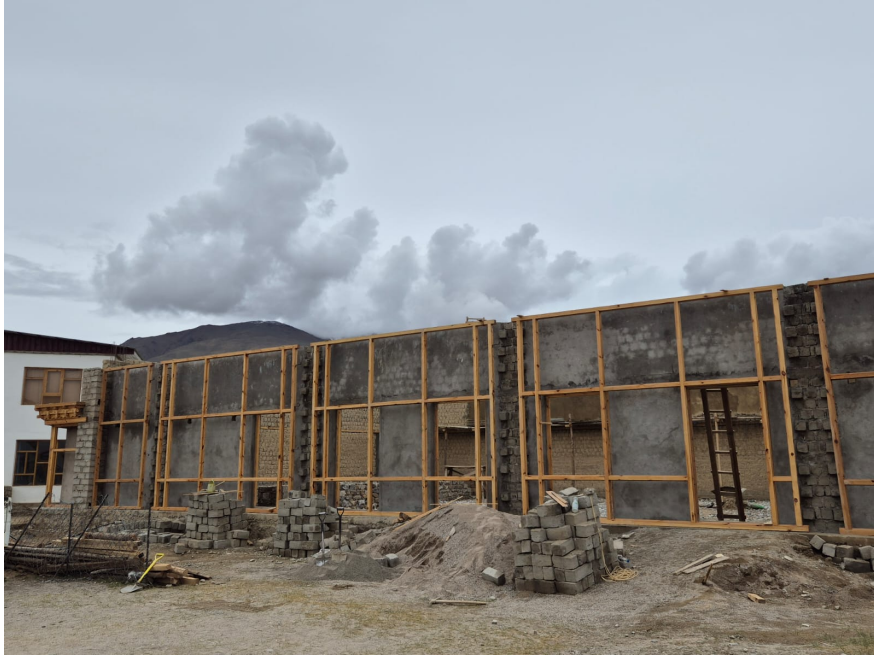
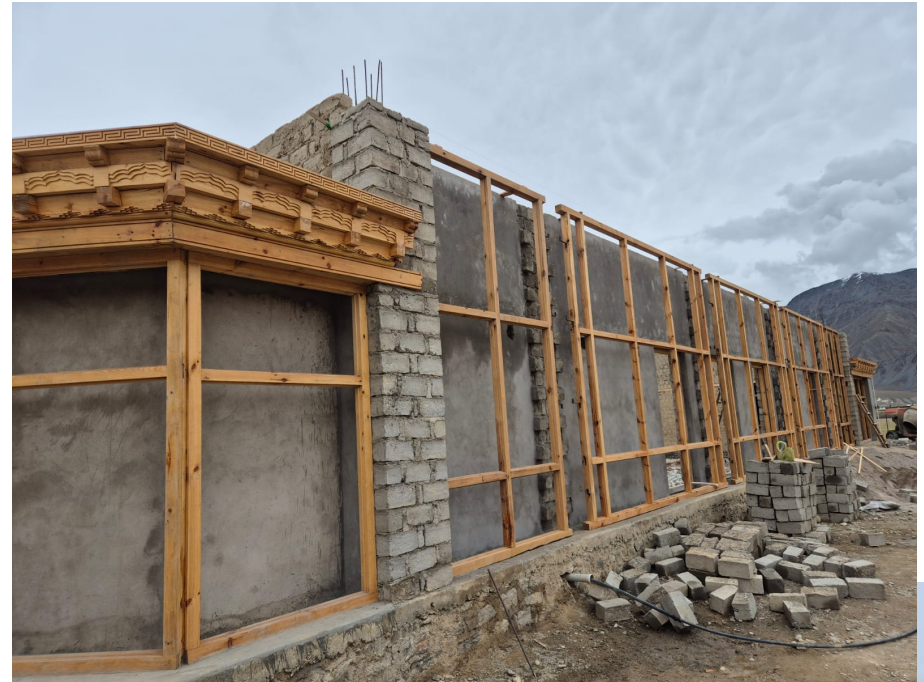
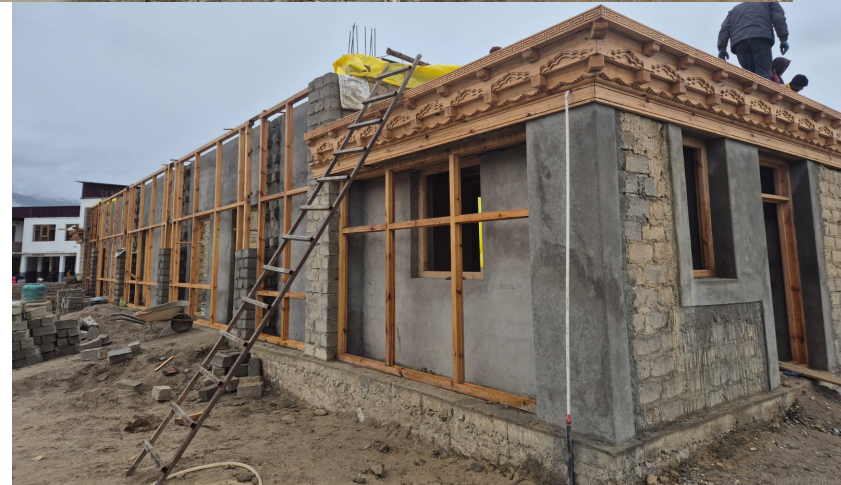
Status of Work as on 02/09/2025

We are pleased to report that the **brickwork for all sides of the building has been fully completed**. The project has now progressed to the **plastering phase** for both the exterior and interior façades. Additionally, the **boys' and girls' changing rooms, cafeteria, and kitchen** have reached completion with respect to major structural works, including roofing and plastering. These milestones mark significant progress towards the overall completion of the project and set the stage for subsequent finishing works.

The **civil works of the boys' and girls' changing rooms, cafeteria, and kitchen** have been completed, including plastering and roofing. In the coming days, **painting, glazing, and electrification** works will be initiated.

The **electrification of the Main Hall** and the completion of the **steel truss roofing** are scheduled for the **end of September**. By the same timeline, the **installation of door shutters and glazing of the south façade** will also be completed.
